**RADIOGRAPHIC DETERMINATION OF THE LAY-UP
INFLUENCE ON FATIGUE DAMAGE DEVELOPMENT UNDER
BEARING/BYPASS CONDITIONS**

In Partial Fulfillment
of the Requirements for the Degree
Master of Science in Mechanical Engineering in the
School of Mechanical Engineering

Georgia Institute of Technology
May 2009

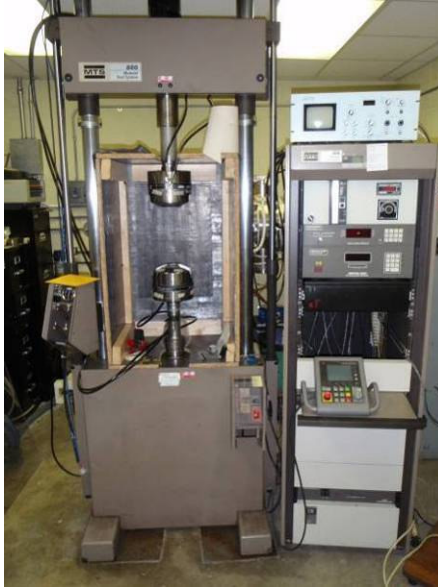
Figure 20: 245 kN (55 Kip) MTS servo-hydraulic test frame with lead lined enclosure

The fatigue testing was performed on a 245 kN (55 kip) MTS servo-hydraulic test frame with 98 kN (22 kip) hydraulic Surfalloy-coated grips. The machine, shown in Figure 20, was equipped with a TestStar IIs data acquisition and control system, and the MTS Basic TestWare software package was utilized. The test frame was equipped with a lead enclosure for radiographic purposes.

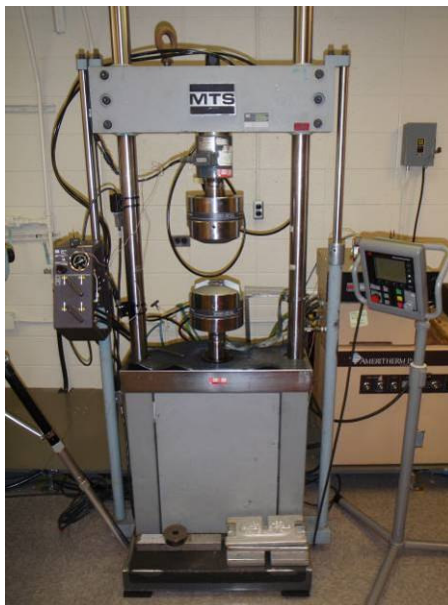
Figure 21: 98 kN (22 kip) MTS servo-hydraulic test frame

During a maintenance period on the 98 kN (22 kip) test frame, a 98 kN (22 kip) MTS servo-hydraulic test frame with hydraulic Surfalloy-coated grips was used. The machine, shown in Figure 21, was equipped with a TestStar IIs data acquisition and control system, and the MTS Basic TestWare software package was utilized.

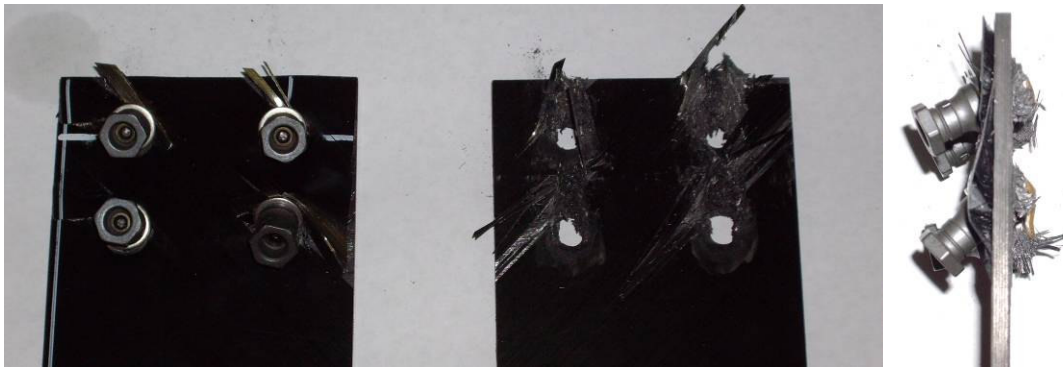
Figure 22: Single shear specimen failure by bolt pull through

Initially, test specimens were arranged in a single shear configuration as seen in Figure 17. All attempts were made to make the loading as symmetric as possible. However, because of the configuration, there is some inherent eccentricity in the loading. This eccentricity causes a bending moment about the center of the specimen. This bending moment in turn causes out of plane deflection. This causes the stress states and damage mechanisms to be much more complicated than simple bearing loading found in a double shear configuration shown in Figure 18. Because of this complex stress state, specimens experienced failure by bolt pull through and shear out at much lower loads than expected. Some images of these failures can be seen in Figure 22 and Figure 23. There was also very little documentable damage progression under the single shear configuration. This was the motivation to switch to the double shear configuration.

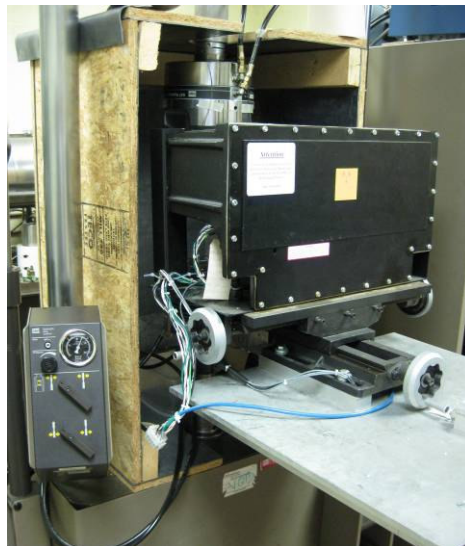
Figure 29: Faxitron unit positioned for X-ray

The portable x-ray unit, shown in Figure 28, was positioned as seen in Figure 29. Alignment was guaranteed by a riser arm equipped with a safety interlock, aligning marks on the floor, and visual cues on the radiation enclosure. The parameters for the Faxitron 110 kV x-ray unit were set differently for the two film types. The initial parameters for the Polaroid film were a voltage of 33 kV, current 3 mA, and time of 73 seconds, based on previous research [35] [36]. The parameters had to be changed for the new Kodak film. These parameters were optimized through trial and error. The parameters for the Kodak film were a voltage of 25 kV, current 3 mA, and a time of 35 seconds. After the room was cleared, the door was closed, enabling the final safety interlock. The specimen was then irradiated to determine the existing damage within the hole pattern. The image would then be processed in accordance with 3.4.2.
